# THE LEUCHTER REPORTS

CRITICAL EDITION

**FRED A. LEUCHTER · ROBERT FAURISSON · GERMAR RUDOLF**

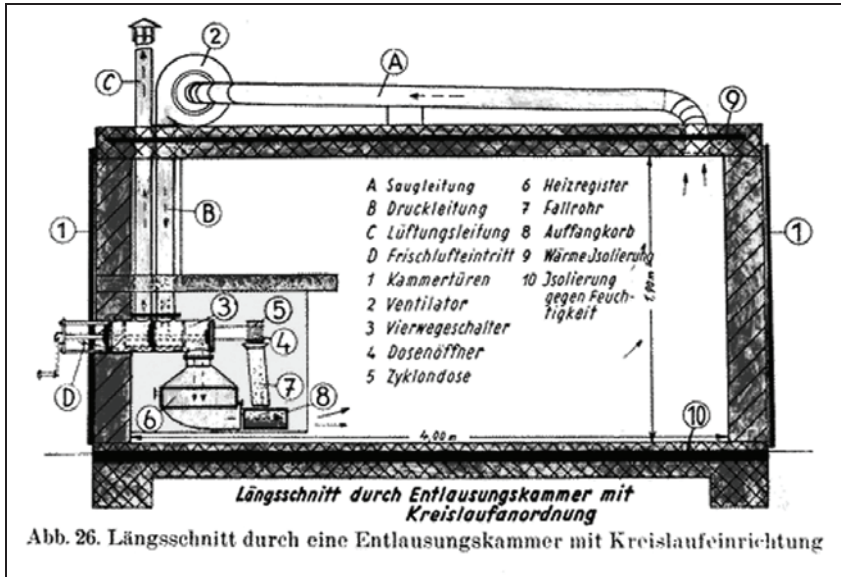
**Fig. 3: DEGESCH delousing chamber with circulation feature.**<sup>52</sup> This design was developed in the late 1930s / early 1940s and became a standard in Germany during the war. It was, however, not installed in all concentration camps, which were frequently equipped with makeshift delousing chambers. Editor's note.

<sup>58</sup> The procedure can be vastly accelerated when using special fumigation chambers designed like the DEGESCH "Kreislaufanlage" (circulation facility), see Gerhard Peters, E. Wüstinger, "Entlausung mit Zyklon-Blausäure in Kreislauf-Begasungskammern. Sach-Entlausung in Blausäure-Kammern," *Zeitschrift für hygienische Zoologie und Schädlingsbekämpfung*, 32 (10/11) (1940), pp. 191-196; cf. also F.P. Berg, "The German Delousing Chambers," *Journal of Historical Review*, 7(1) (1986), pp. 73-94.

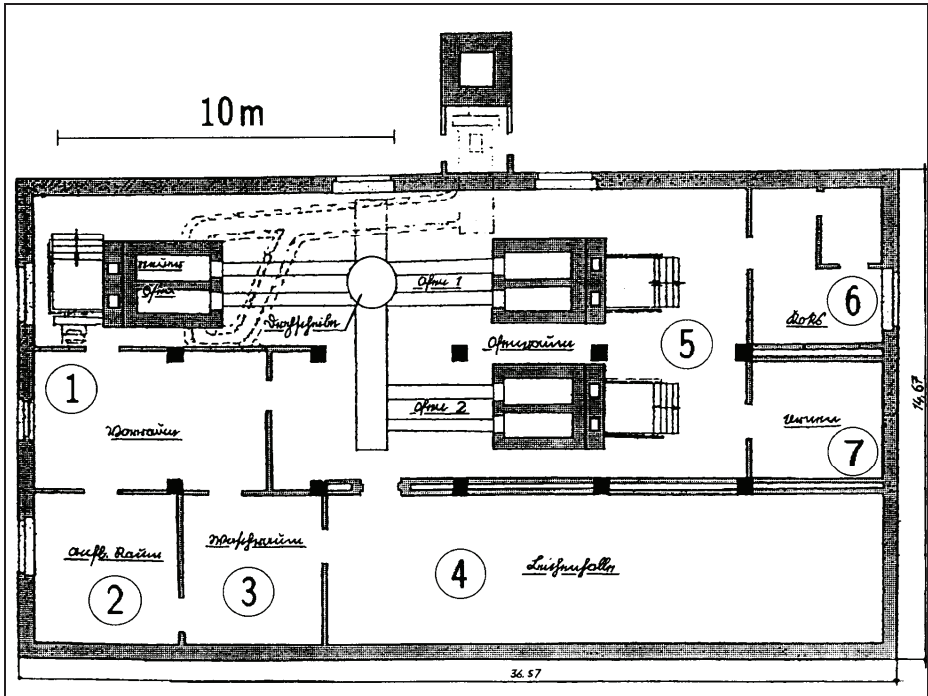
**Fig. 4:** Ground plan of Crematorium I in Auschwitz I/Main Camp in its original condition. The morgue was later allegedly used as a homicidal gas chamber.<sup>144</sup>

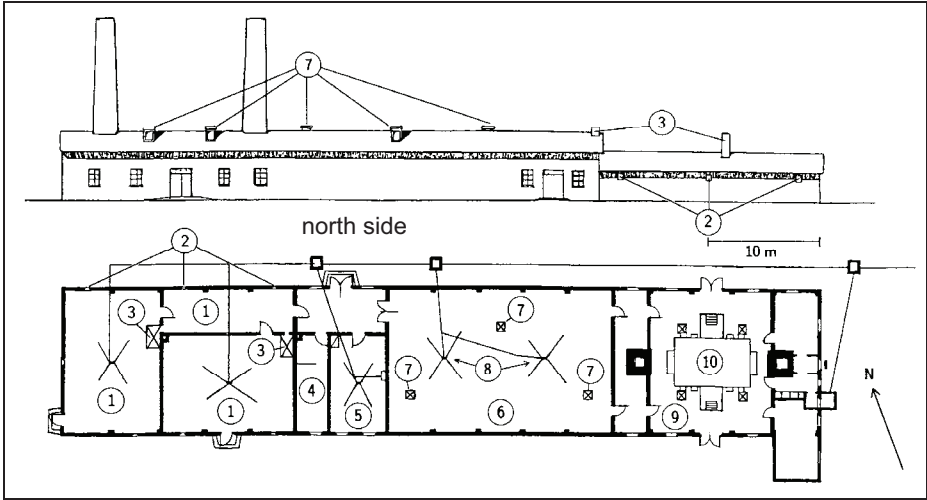
**Fig. 7:** North elevation (above) and ground plan (below) of crematorium IV and/or V (mirror image) in Auschwitz II/Birkenau camp.<sup>159</sup>

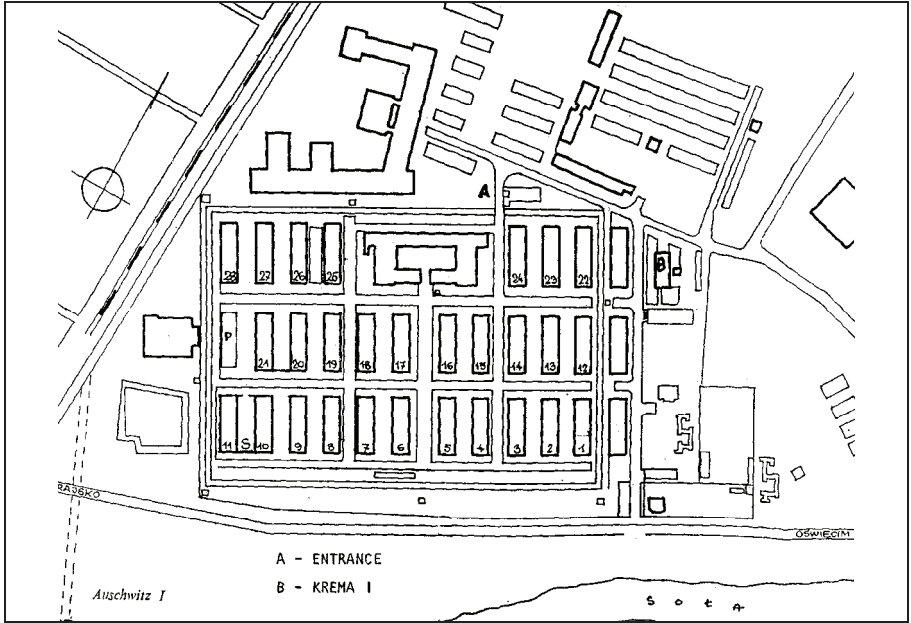
Fig. 9: Plan of the Auschwitz main camp (Auschwitz I or Stammlager) according to information brochure of the Auschwitz State Museum.

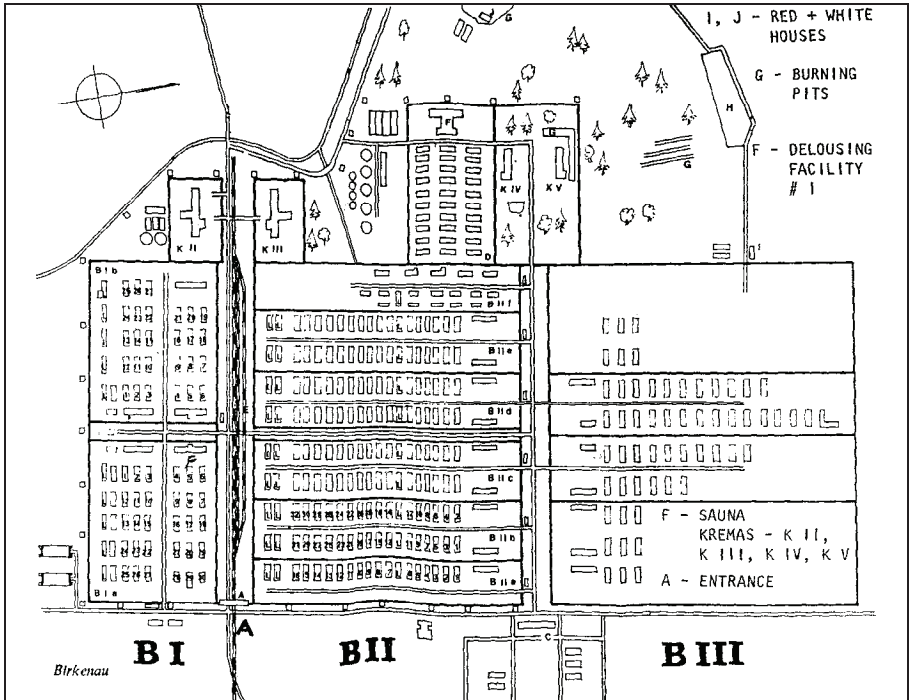
Fig. 10: Plan of the Birkenau camp (Auschwitz II) according to information brochure of the Auschwitz State Museum.

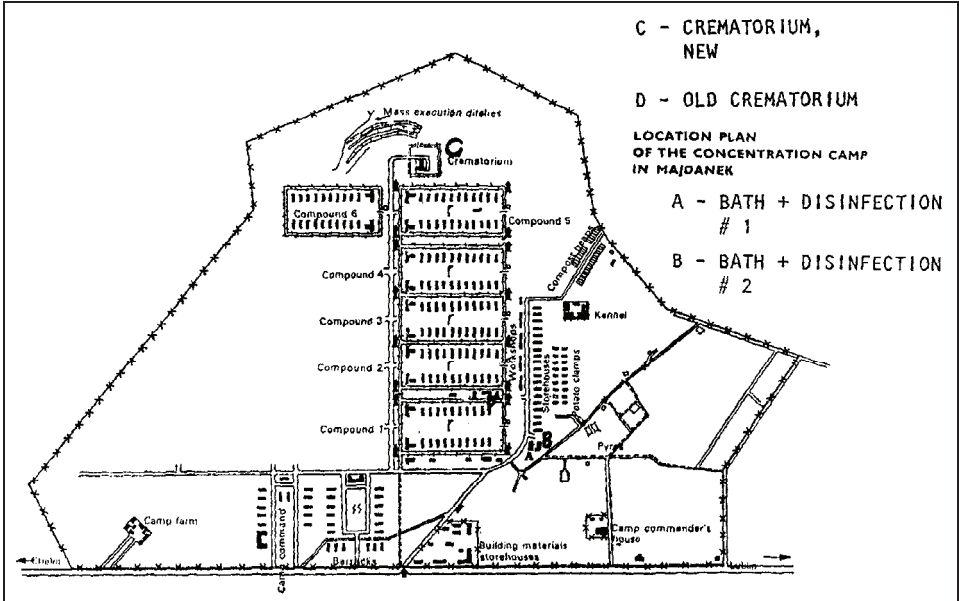
Fig. 11: Plan of the Majdanek concentration according to information brochure of the Majdanek State Museum.

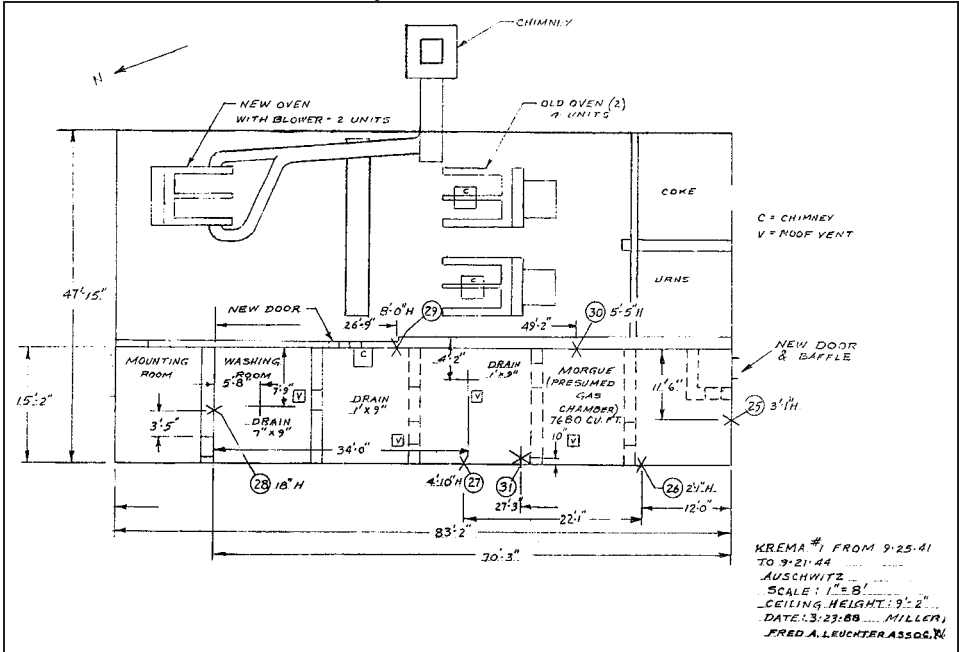
Fig. 12: Floor plan of Krematorium I in Auschwitz main camp, drawn by H. Miller, Fred A. Leuchter Associates. Numbers in circles denote locations where wall sample were taken.

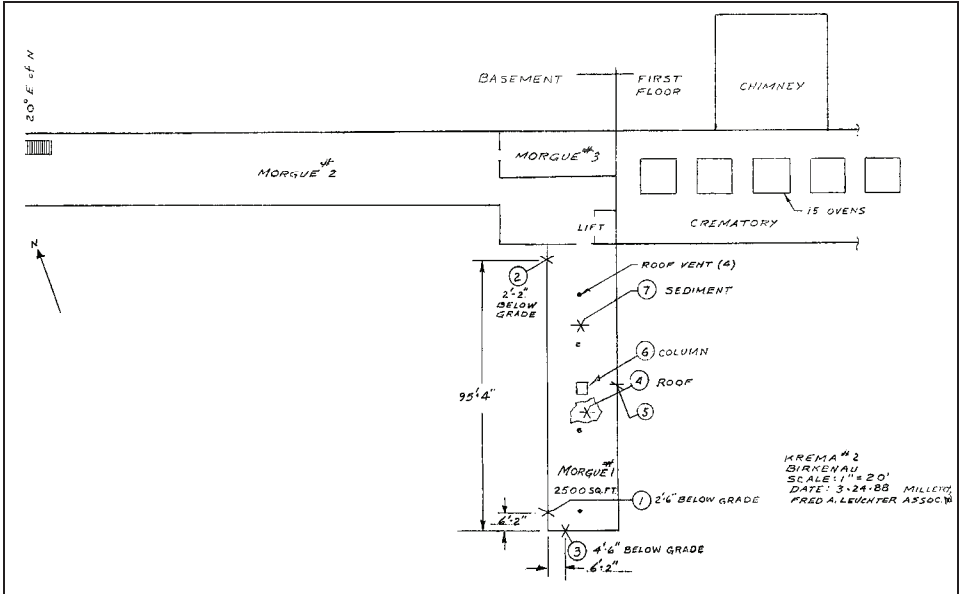
Fig. 13: Floor plan of Krematorium II in Auschwitz Birkenau, drawn by H. Miller, Fred A. Leuchter Associates. Numbers in circles denote locations where wall sample were taken. Note: The "Roof Vent (4)" do not exist; see document on next page.

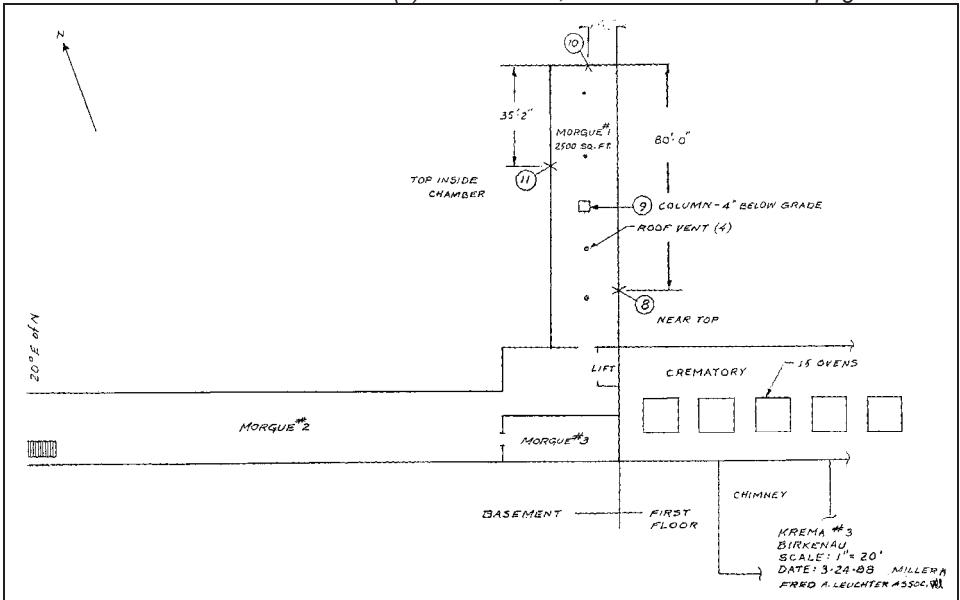
Fig. 14: Floor plan of Krematorium III in Auschwitz Birkenau, drawn by H. Miller, Fred A. Leuchter Associates. Numbers in circles denote locations where wall sample were taken. Note: The "Roof Vent (4)" do not exist; see document on next page.

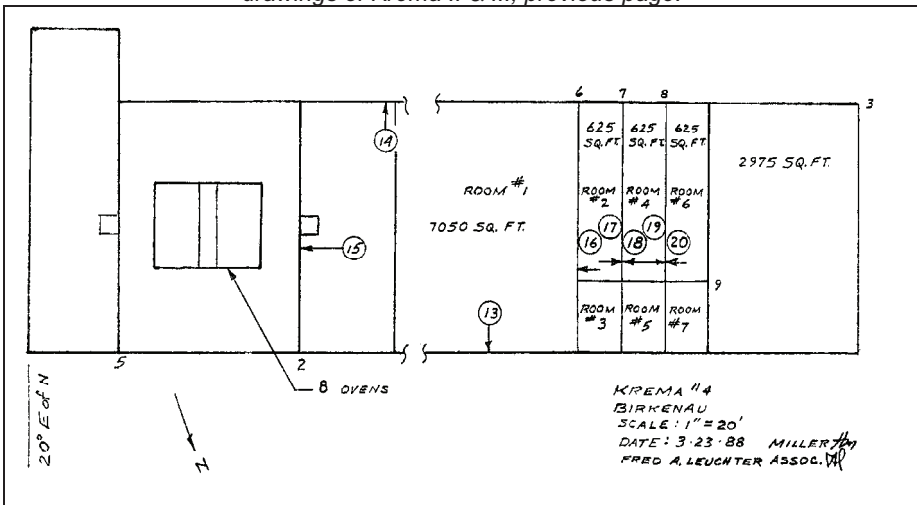
Fig. 16: Floor plan of Krematorium IV in Auschwitz Birkenau, drawn by H. Miller, Fred A. Leuchter Associates. Numbers in circles denote locations where wall sample were taken.

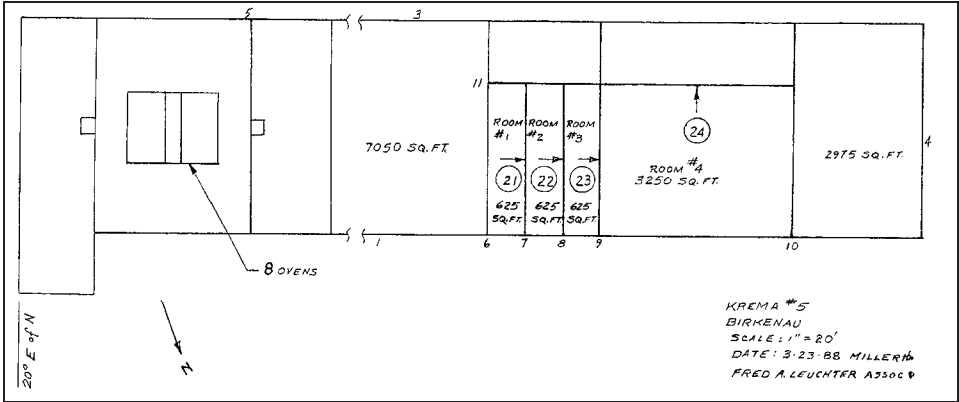
**Fig. 17:** Floor plan of Krematorium V in Auschwitz Birkenau, drawn by H. Miller, Fred A. Leuchter Associates. Numbers in circles denote locations where wall sample were taken.

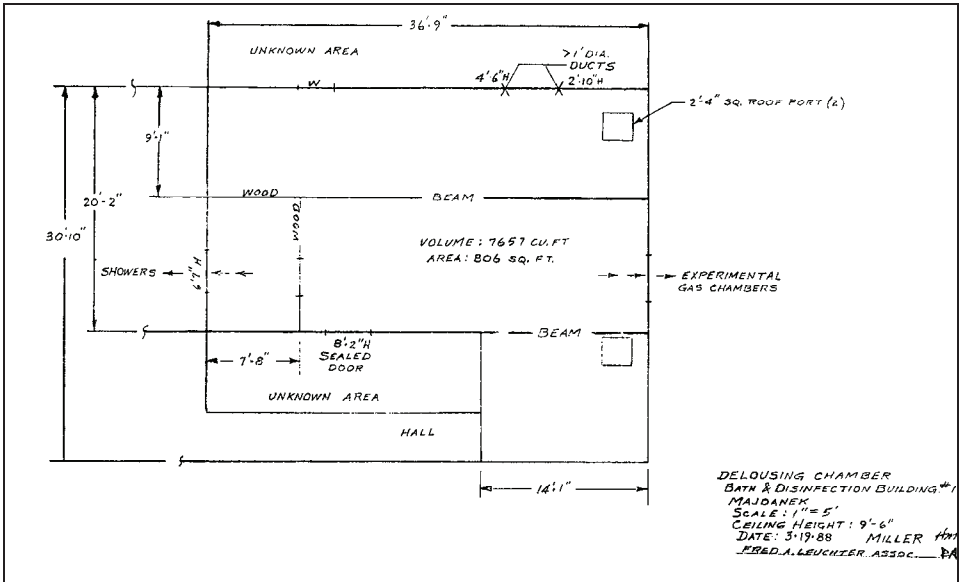
**Fig. 18:** Floor plan of Bath & Disinfection Building #1 at the Majdanek camp, drawn by H. Miller, Fred A. Leuchter Associates.

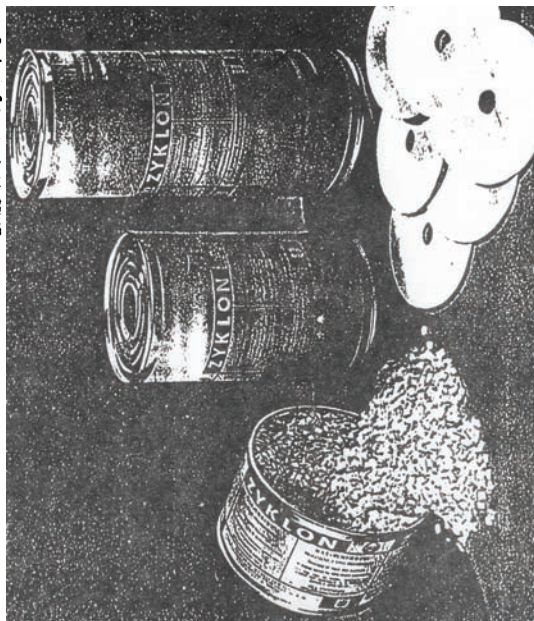
ZYKLON tins with the gas-impregnated material: Snippets and discs.

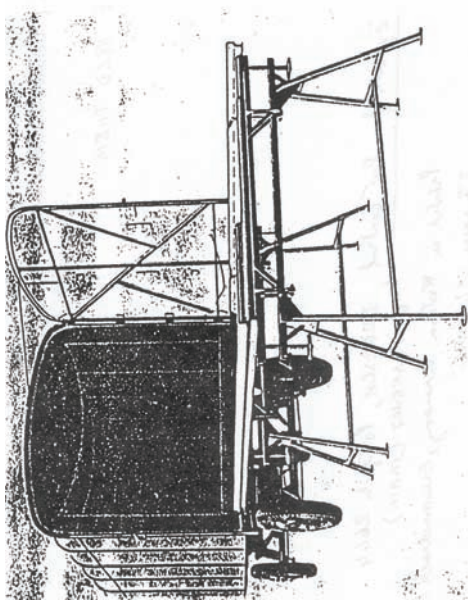
Mobile fumigation chamber, capacity 20 cubic metres.  
The standard equipment for the protection of plants and stored products.

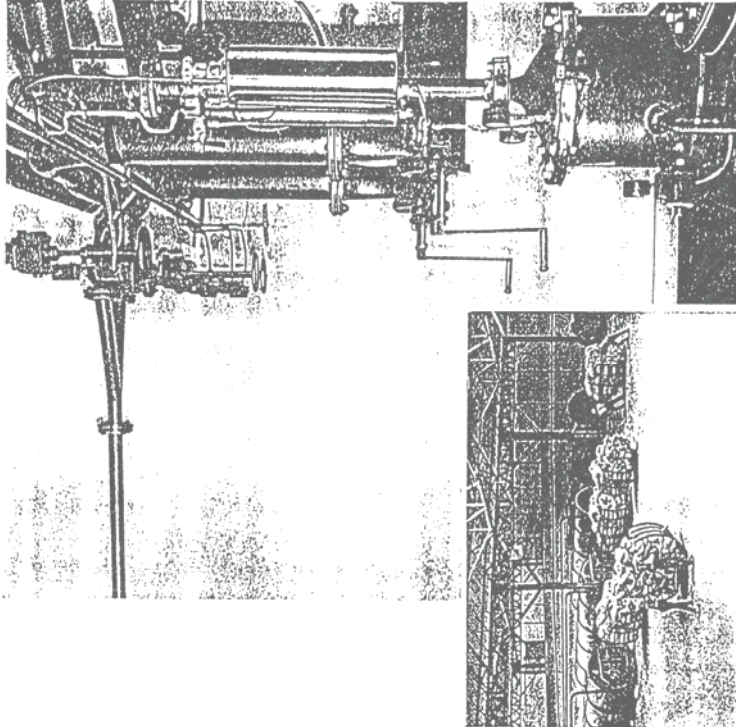
Two ZYKLON vaporizers with special lin openers and a vaporizer for liquid hydrocyanic acid in the generator room of the vacuum fumigation plant, Port of Castellón.

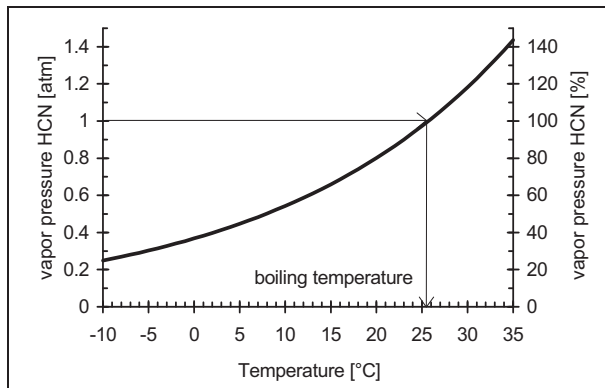
**Graph 1:** Vapor pressure of hydrogen cyanide in percentage of air pressure as a function of temperature.

nide gas would never take place in air. However, the 5% lower density of pure hydrogen cyanide gas compared to air – this corresponds to the density difference of air with a temperature difference of 15°C or 27 °F – can very well lead to a density convection, when pure gaseous hydrogen cyanide is released in a location with

the same temperature as the ambient air. The gas would then rise slowly, but gradually mix with the ambient air. But to conclude from this that hydrogen cyanide vapors always rise would be an incorrect conclusion. At 15°C, for example, on physicochemical grounds, no concentrations higher than 65% of hydrogen cyanide can occur in air (see Graph 1); the density of such a mixture lies only approximately 3% below that of air. Furthermore, a great deal of energy is withdrawn from the ambient air by the evaporating hydrogen cyanide. Consequently, the ambient temperature sinks until exactly as much energy is transported to the liquid HCN as needed for the decelerated evaporation at the corresponding lower temperature. It is therefore theoretically possible that hydrogen cyanide vapors containing little HCN, which are cold, are denser and thus heavier than the surrounding air.

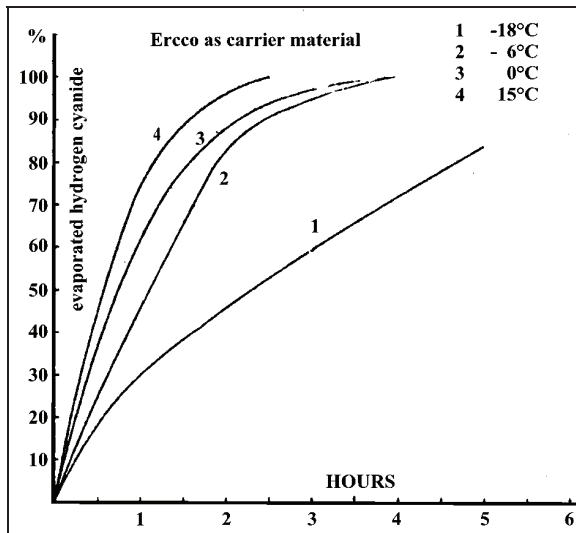
**Graph 2:** Evaporation rate of hydrogen cyanide from the Erco carrier material (gypsum with some starch) at various temperatures and fine distribution, according to R. Irmscher/DEGESCH 1942.<sup>182</sup>

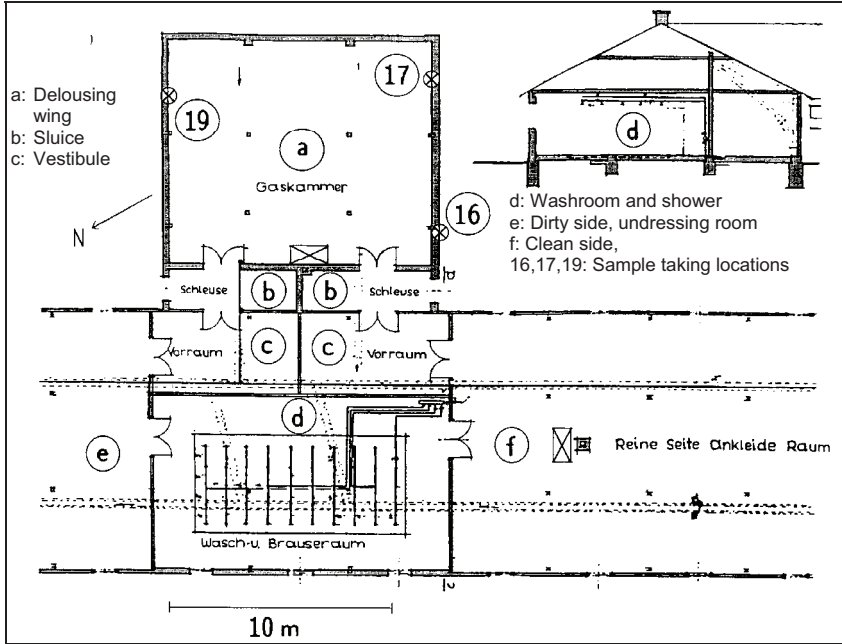
**Fig. 23:** Ground plan of the HCN disinfestation wing of Building 5a before building alterations (mirror image) and BW 5b today. BW 5b sample-taking locations for the Rudolf Report drawn in.<sup>194</sup>

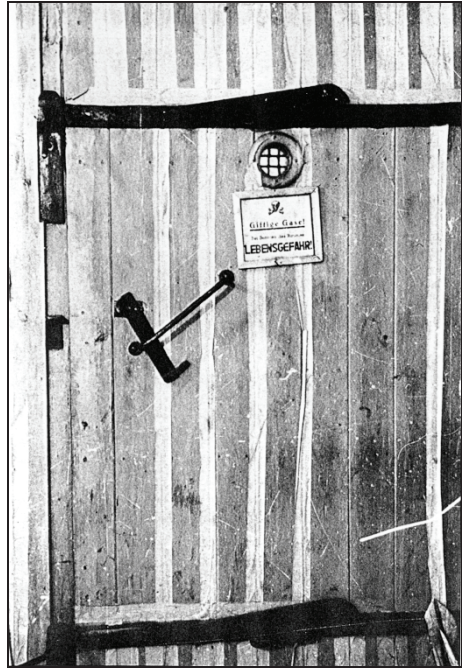
**Fig. 25:** *Wooden disinfestation chamber door at Auschwitz rendered provisionally gas-tight with peephole and metal protection grid. This is what the gas-tight doors for the homicidal ‘gas chambers’ are supposed to have looked like. Note the extremely flimsy latch to lock the door.<sup>196</sup>*

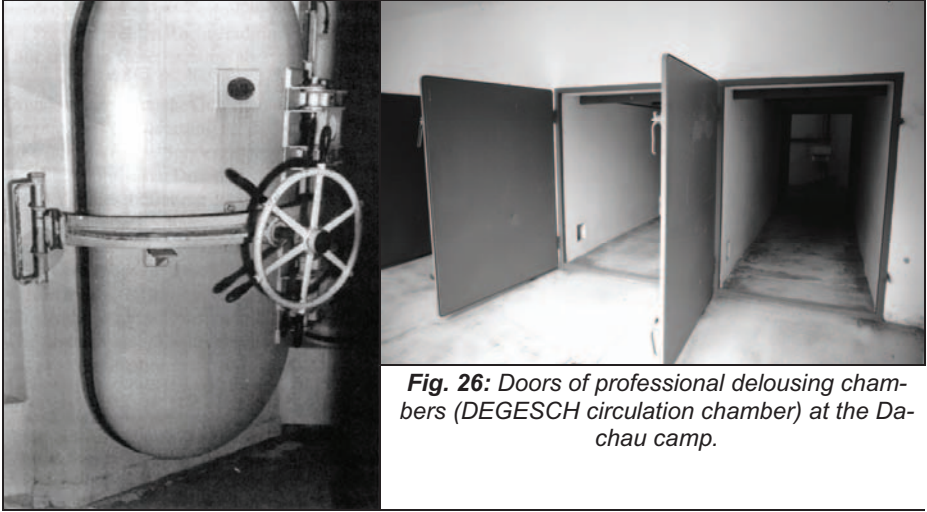
**Fig. 26:** Doors of professional delousing chambers (DEGESCH circulation chamber) at the Dachau camp.

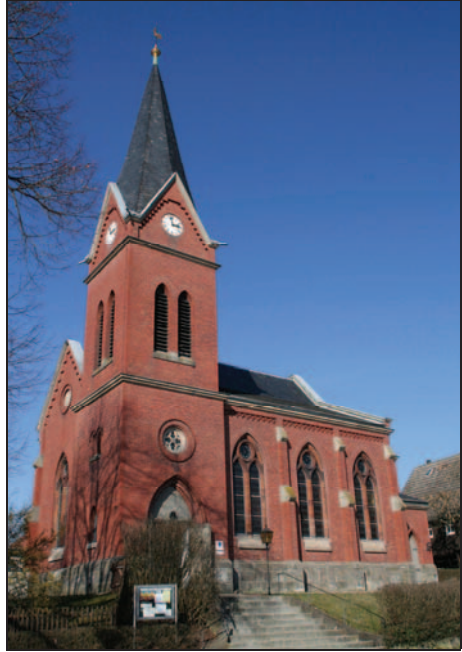
**Fig. 35:** In August 1976, the Protestant church at D-96484 Meeder-Wiesenfeld was fumigated with Zyklon B. Subsequently, blue-colored stains appeared all over the plaster (see Fig. 36).

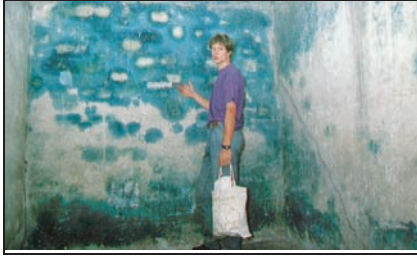
**Fig. 37:** Blue staining of the interior northwest room in the Zyklon B disinfestation wing of BW 5a in the Birkenau camp. (© Karl Philipp<sup>225</sup>)

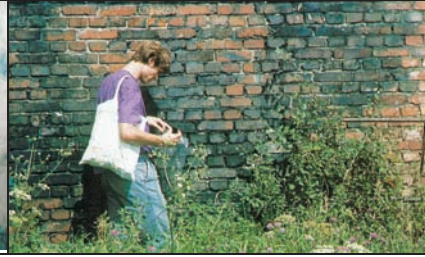
**Fig. 38:** Blue staining of the exterior southwest wall of the Zyklon B disinfestation wing of BW 5b in the Birkenau camp. (© Karl Philipp<sup>225</sup>)

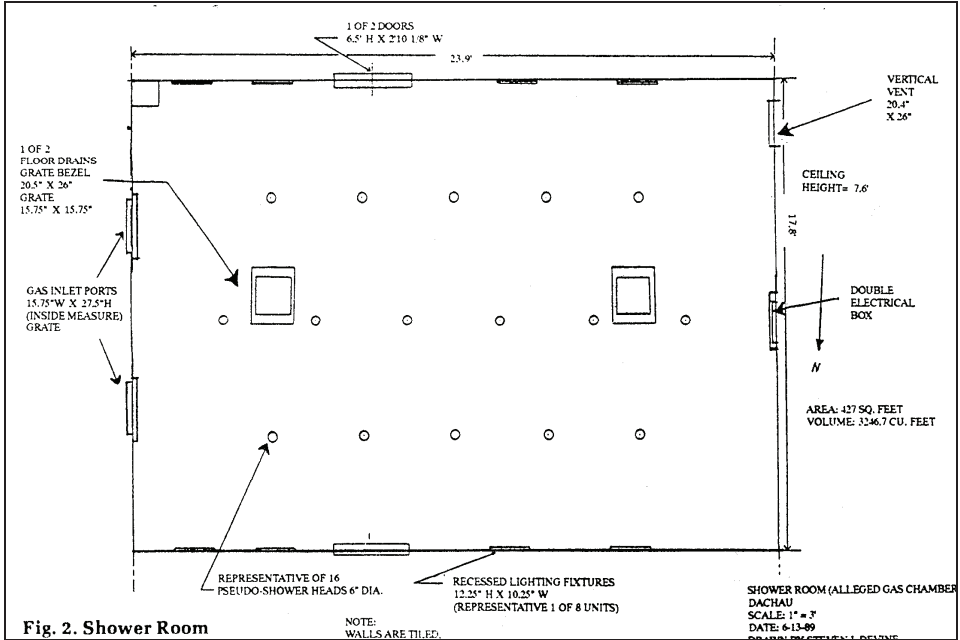
**Fig. 46: Floor plan of the shower room in "Barracks X" at the Dachau camp.**

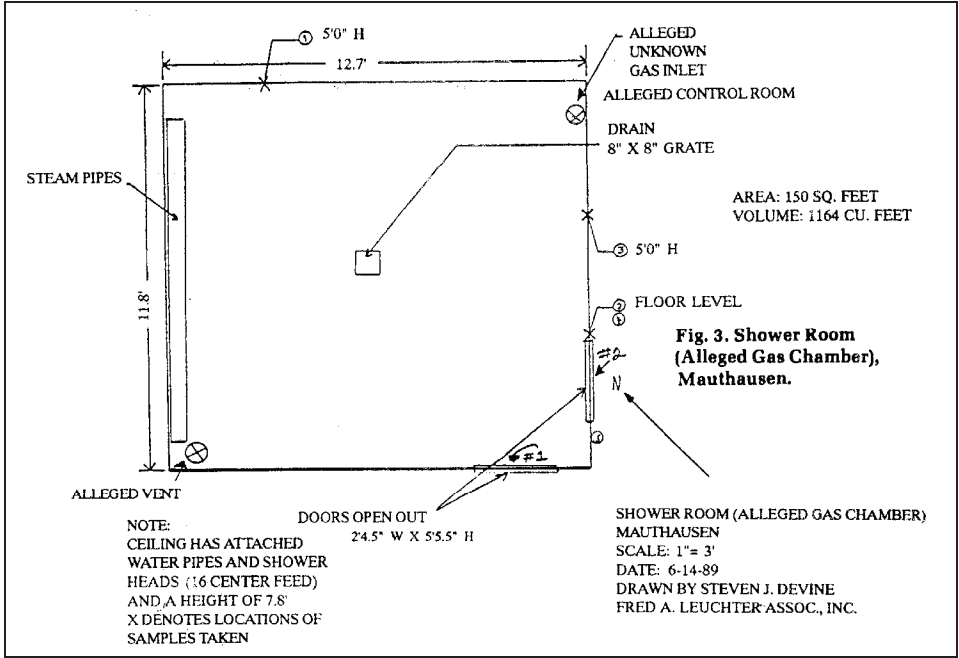
**Fig. 48:** Floor Plan of the shower (alleged gas chamber) at Mauthausen camp, Austria. Encircled X denote locations of wall samples taken.

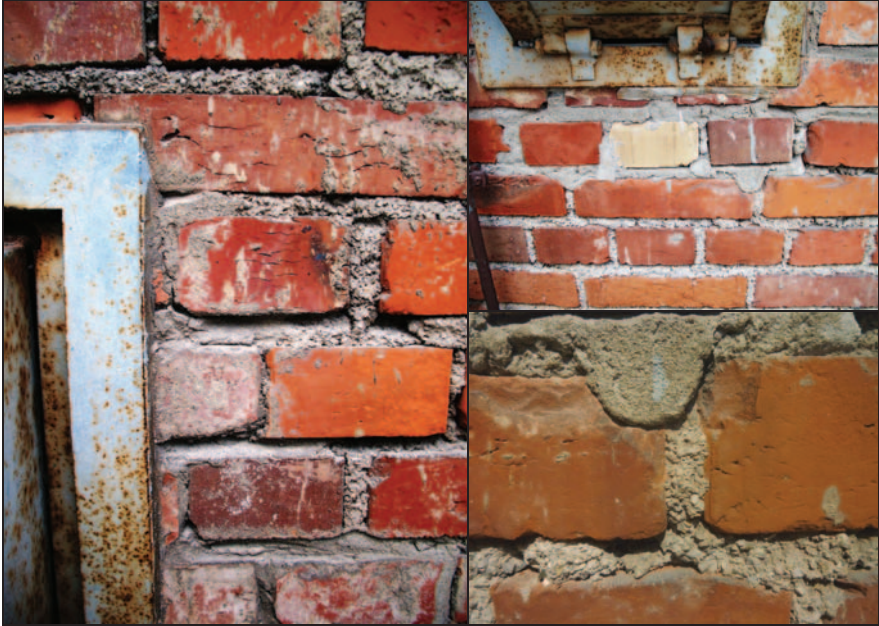
**Ill. 49a (left), b, c (right):** external view of the alleged "Zyklon B introduction chutes" of the alleged gas chamber at Dachau. The different mortar used for the surrounding bricks proves that these holes were opened only after the wall had already been erected.

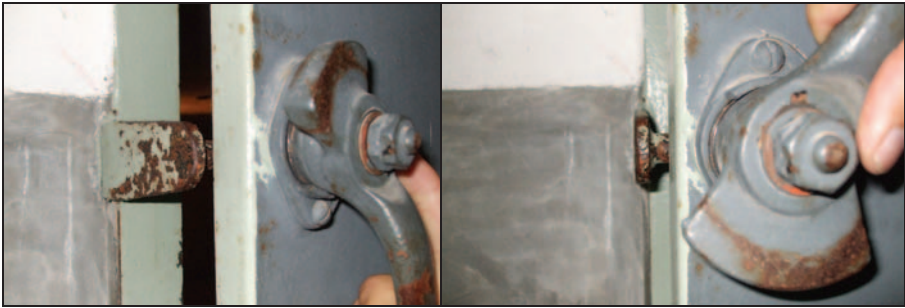
*Ill. 59a & b: The doors to the alleged gas chamber at Dachau cannot be closed nowadays: a missing closing mechanisms and blocking steel pins welded to the frame prevent this.*

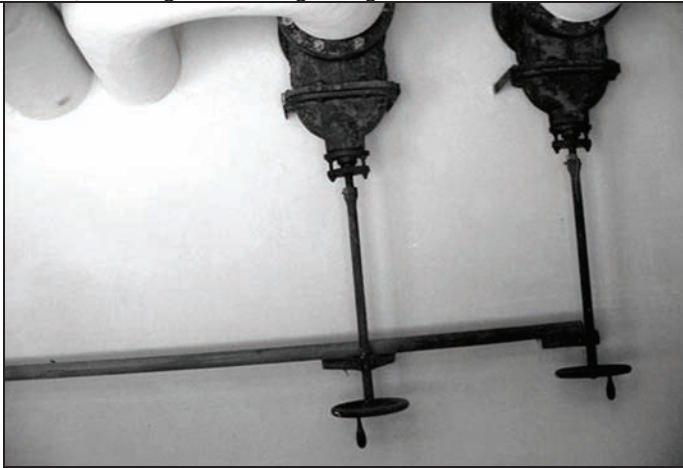
**Fig. 62:** Heavy insulated hot water (or steam?) pipes in the room behind the alleged gas chamber of Dachau camp, leading into the space above the current room.<sup>1</sup>

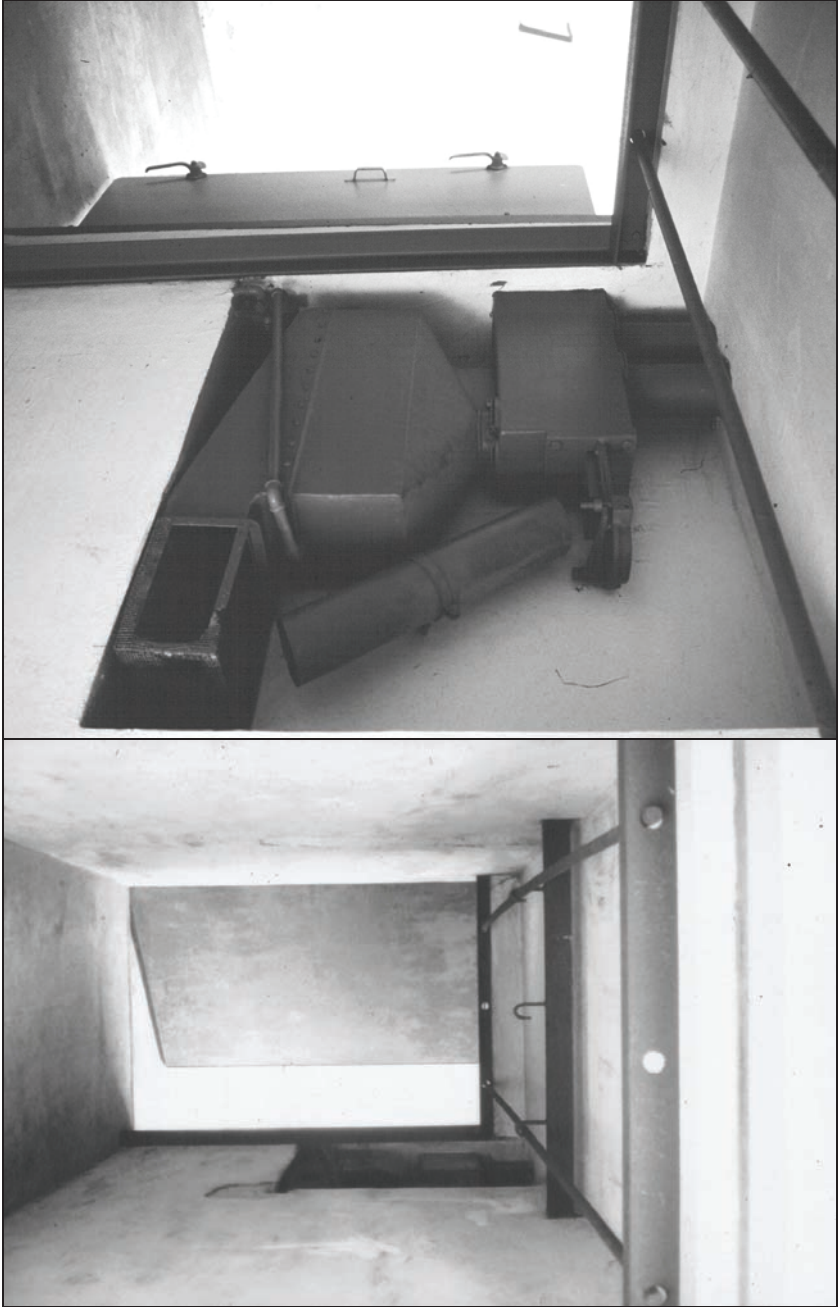
**Fig. 68 & 69:** Interior of disinfection chamber at Dachau; left: DEGESCH Kreislaufanlage (circulation device); right: view through the chamber.<sup>5</sup>

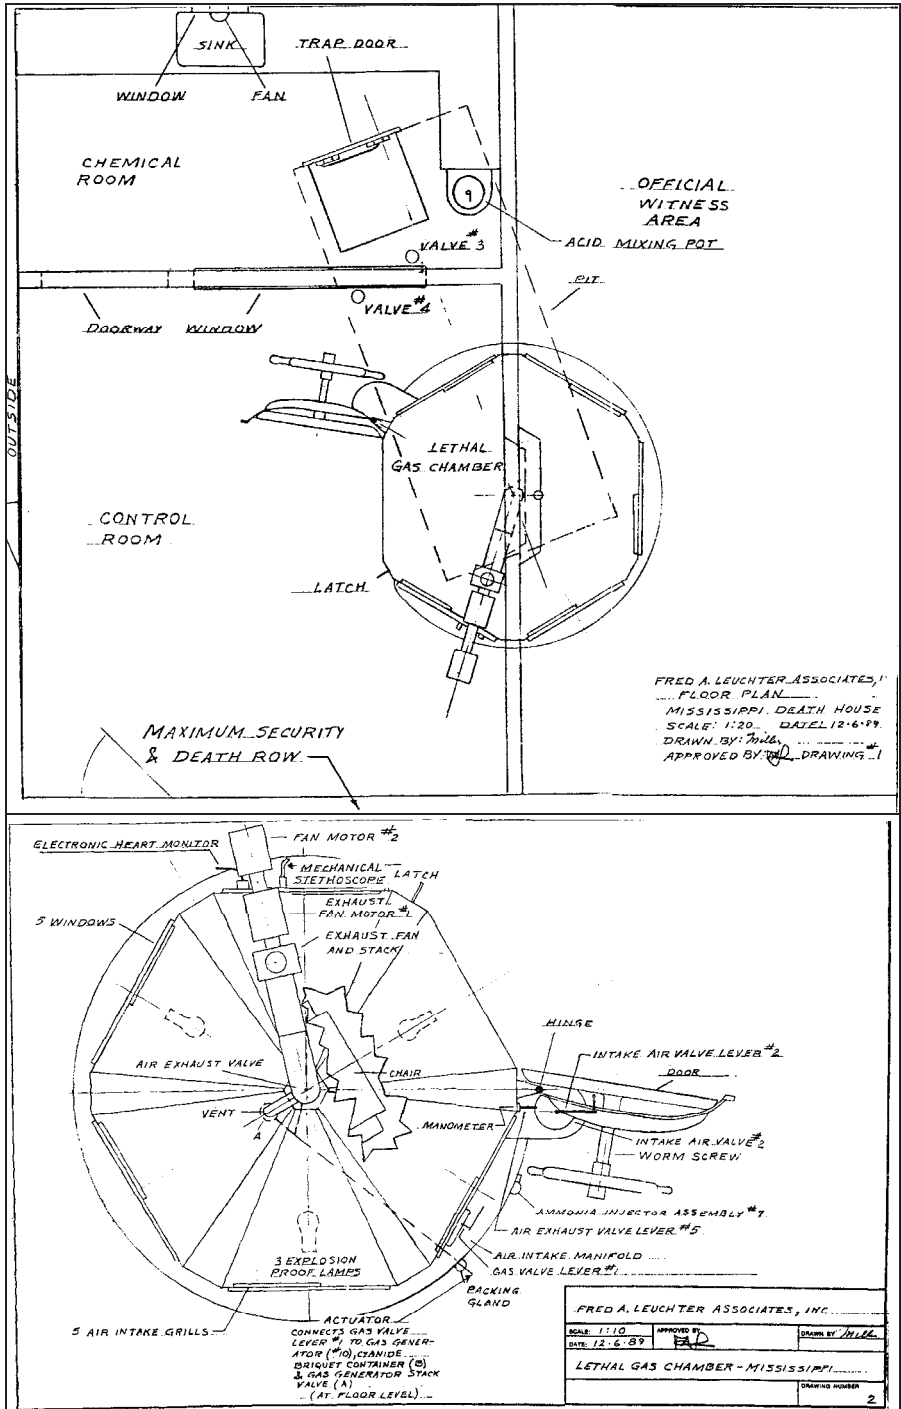
Fig 80 & 81: Technical drawings of the Parchman (Miss.) execution gas chamber.

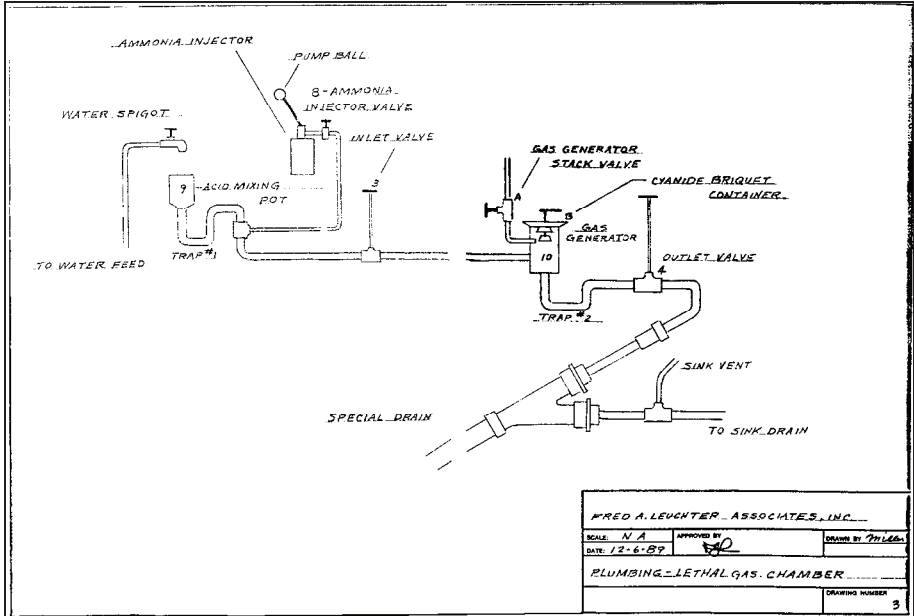
Fig 82: Technical drawing of gas generator of the Parchman (Miss.) execution gas chamber.

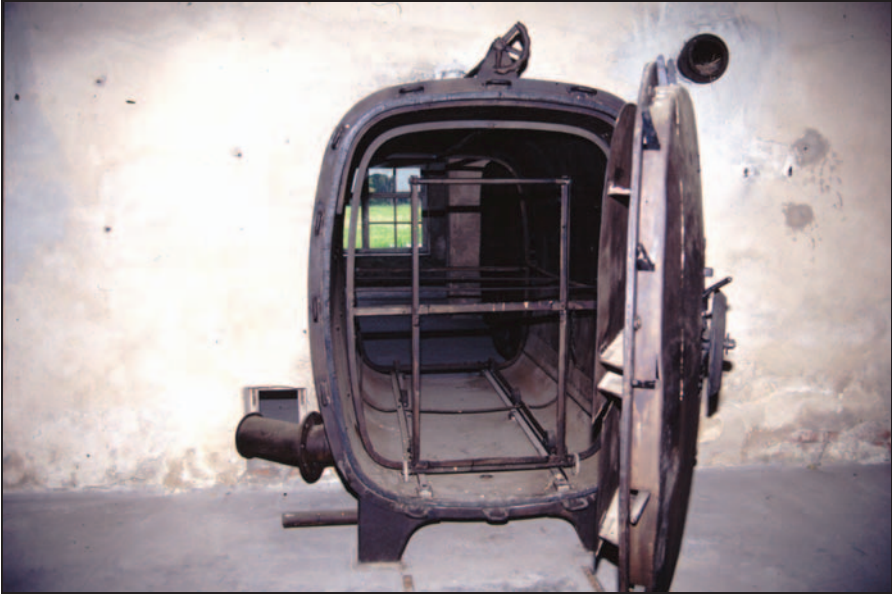
**Fig. 89:** Hot-air-disinfection autoclave in the so-called "Zentralsauna" in Auschwitz-Birkenau with similar doors as used for the U.S. execution gas chambers. Although the German camp authorities had the technology required for constructing execution gas chambers, they did not use it. They used this technology to save the lives of their prisoners instead.

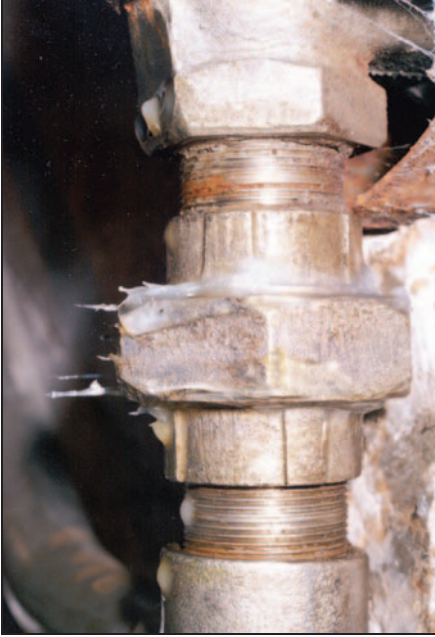
**Fig. 103:** Closeup of plumbing underneath the gas chamber covered in Vaseline to indicate leaks.

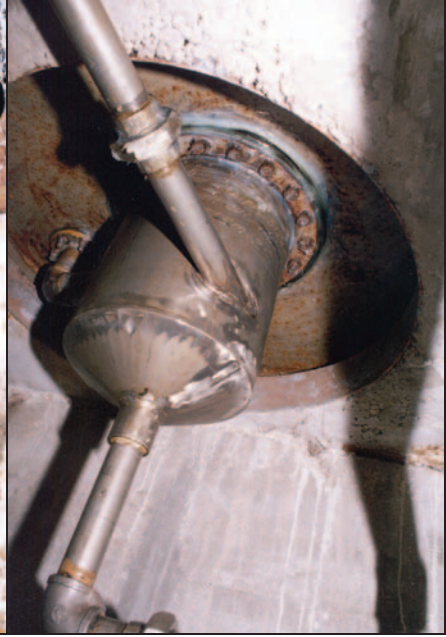
**Fig. 104:** View of stainless-steel plumbing and chemical container directly under seat in gas chamber.

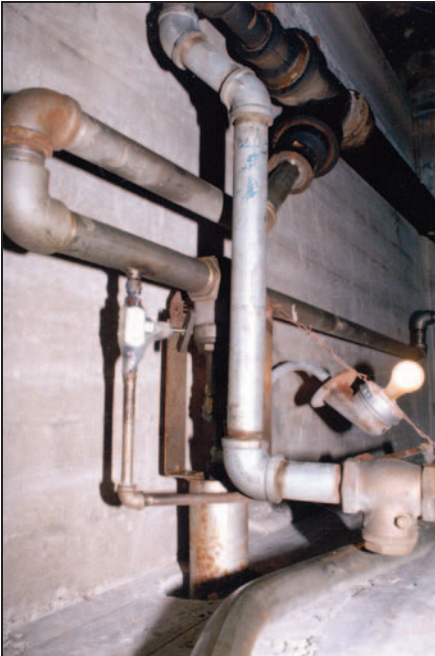
**Fig. 105:** Portion of plumbing and sewage system connecting chemical room to gas chamber.

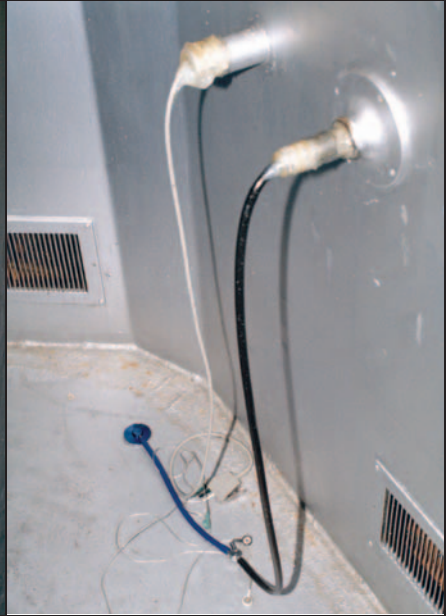
**Fig. 108:** Inside gas chamber where stethoscope and other body monitoring line enter. They are covered in Vaseline to indicate leaks. Fresh air vents on the walls close to the floor.

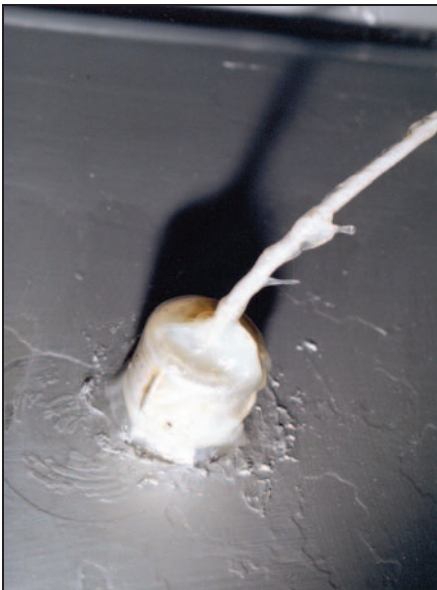
**Fig. 109:** Closeup of where monitoring line enters chamber also coated in Vaseline.
